Manhole Inspection Summary

Manhole # S13II2001MH

Insp Date: **6/30/06 2:30 PM**

Location Address: **2110 NORTHCLIFF DR**

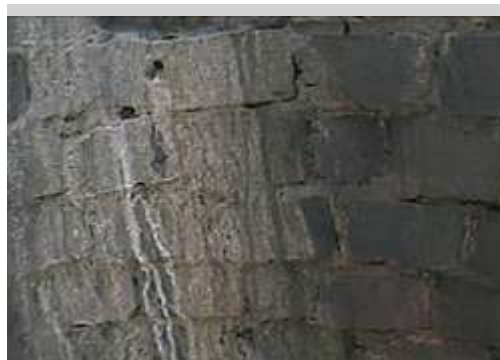
Defect

Condition: ☐ Sound ☐ Cracked ☐ Root Intrusion ☐ Loose Brick ☒ **Deteriorated**

Infiltration: ☐ None ☒ **Joint** ☐ Cracks ☒ **Mortar** ☐ Roots ☐ Wall

Infiltration: ☐ None ☐ Joint ☐ Cracks ☒ **Mortar** ☐ Roots ☒ **Wall**

Adjustment deterioration and infiltration.
Corbel infiltration - other side.
